Australian Government
Department of Defence
Defence Science and
Technology Organisation

Fatigue Testing of AA7050-T7451 with Various Corrosion Prevention Surface Treatments

DSTO-TR-2851

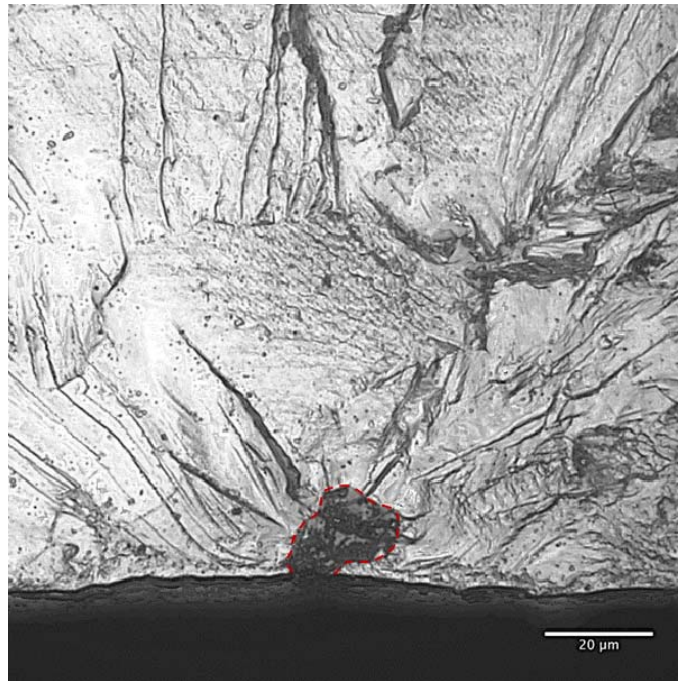
For the machined surfaces, the discontinuity from which the main fatigue crack grew was usually a surface-breaking inclusion, inclusion cluster and/or porosity created during the casting of the original ingot that had been exposed to the free surface during the manufacturing of the coupon. Figure 14 shows an example of a surface-breaking inclusion and Figure 15 shows an example of a surface-breaking inclusion with porosity, both of these had initiated fatigue cracks.

Figure 14: Coupon KF2B8 with a surface-breaking inclusion initiating cracking

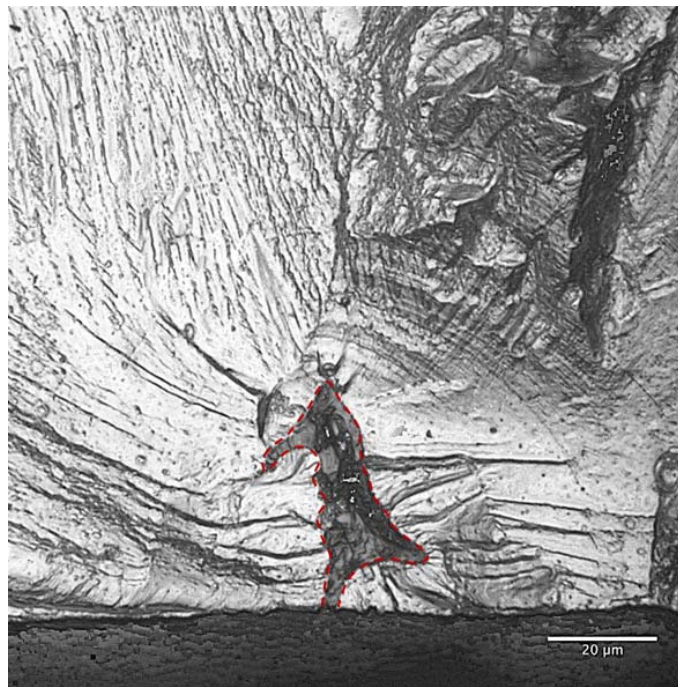
Figure 15: Coupon LMAE-07-L-T with a surface-breaking inclusion cluster associated with porosity causing the onset of fatigue cracking

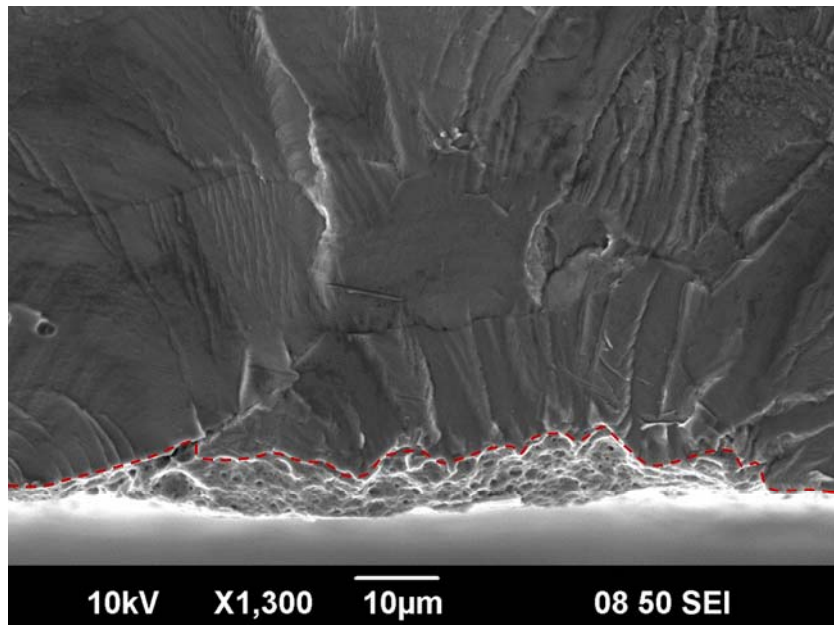
For the etched coupons the discontinuities, usually associated with crack initiation, were pits caused by chemical attack during the etching process. An example of an etch pit is shown in Figure 16. These pits were associated with grain boundaries and sub-grain boundaries, surface breaking inclusions and any associated porosity.

Figure 16: Coupon LM-372 with a shallow pit caused from the etching process highlighted

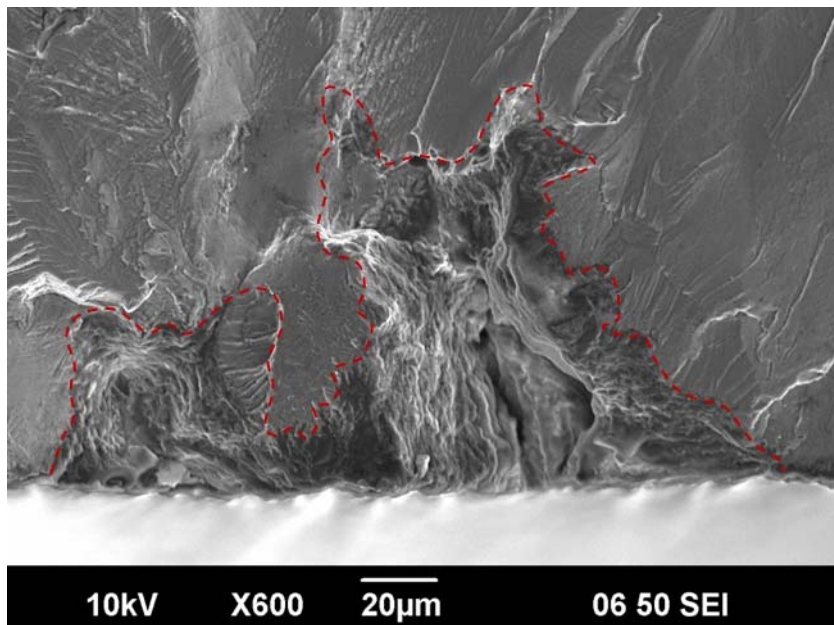
The anodised surfaces also had pits that had lead to fatigue crack onset. These were also caused by chemical attack during one of the water based chemical treatments: caustic degreasing, de-oxidising or anodising. The pits in the anodised coupons were larger than the pits caused by the pre-IVD etching process, in both depth and area, and they were larger than the inclusions in the machined surfaces. Figure 17 shows an example of an anodised pit. The anodising pits tended to be associated with surface breaking inclusions or inclusion clusters and grain boundaries to a lesser extent.

Figure 17: LM-303 with a pit caused from the anodising process leading to the onset of fatigue cracking

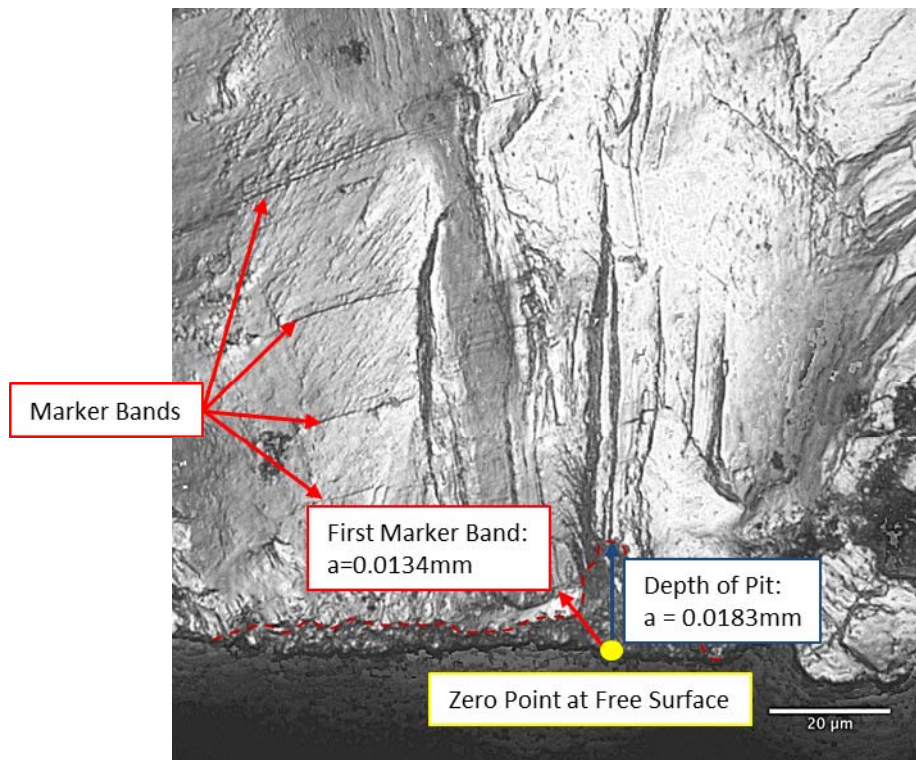
Figure 18: Example of first marker band measurement being smaller than the maximum depth of the initiating discontinuity from coupon LM-151

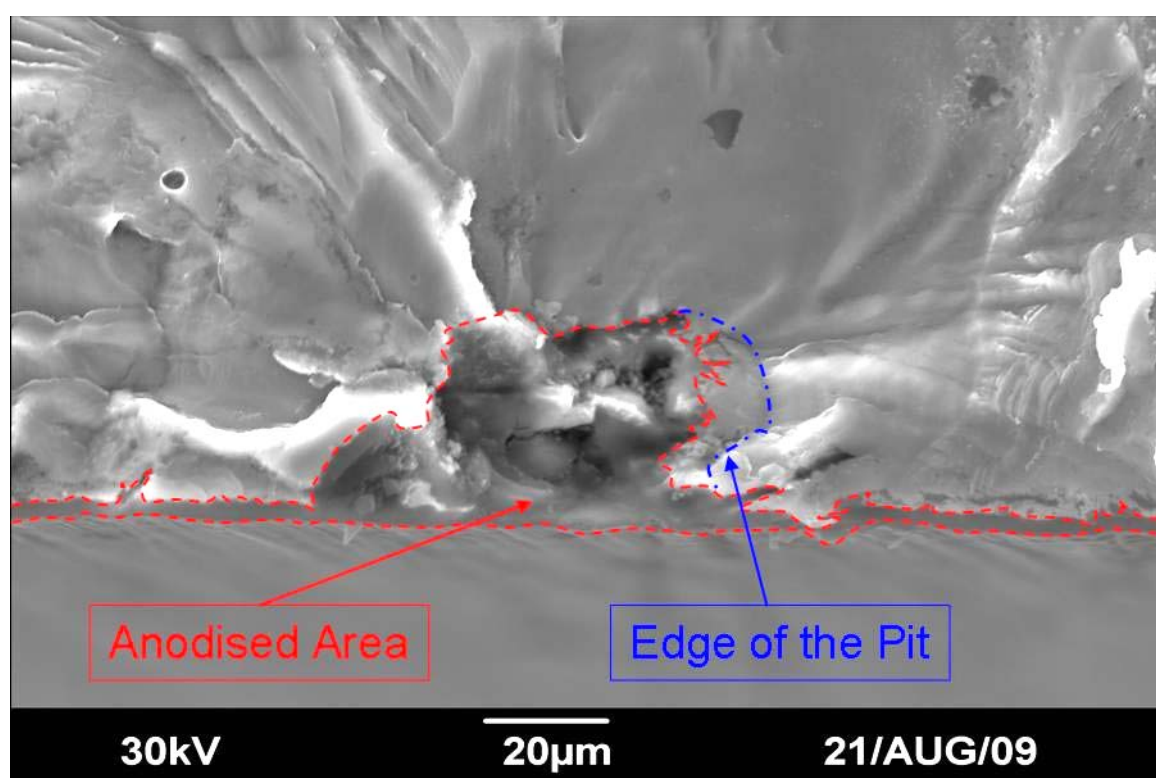
An assessment was undertaken to understand the reasons behind the formation of the larger pits in the anodised coupons. The originating discontinuities for the anodised coupons were examined in the SEM. The example in Figure 26, a SEM photograph of coupon LM-301, shows that the anodic layer could be found within the pit, although it did not completely fill the pit. From this, it can be deduced that the pit was present before the anodic layer was applied. This indicates that the pitting was caused by chemical attack of the surface prior to the anodising process. This observation was verified in other coupons, as shown in Figure 27 from coupon LM-418.

Figure 26: An anodised pit from LM-301 showing the edge of the pit is larger than the anodised area

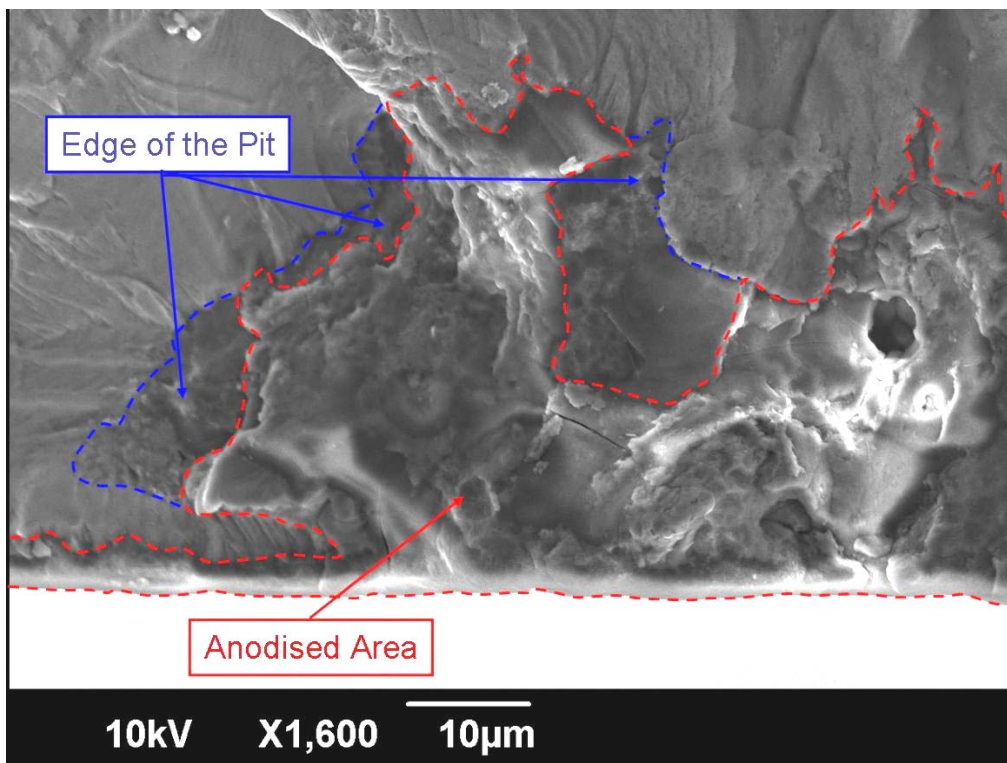
Figure 27: An anodised pit from LM-418 showing the edge of the pit is larger than the anodised area

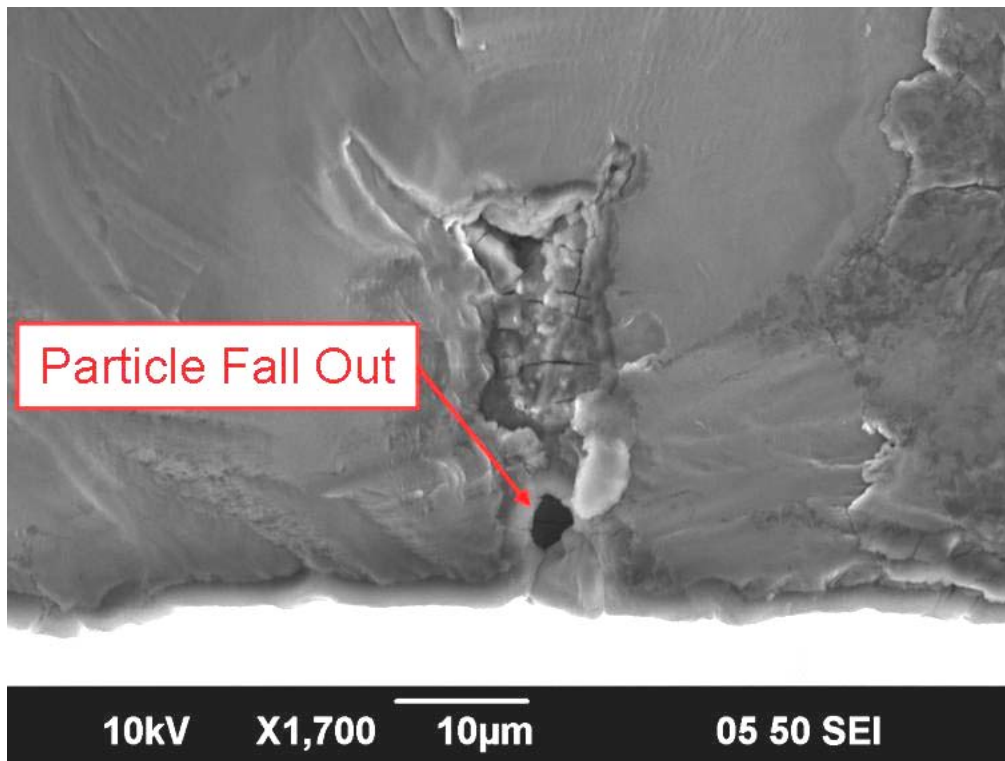
The types of pits caused during the anodising process were also investigated. It was found that the pits were typically associated with surface breaking inclusions or grain boundaries. Figure 28 of coupon LM-136 shows a pit that has formed by the dissolution of an inclusion. Figure 29 from coupon LM-87 shows a pit which has formed at a grain boundary. These larger pits were more frequently the source of crack initiation in the anodised coupons compared to the etched coupons, where the pitting was generally shallower. These pits tended to be long on the surface and were found to be an important source of crack initiation for the anodised coupons. Figure 30 shows an example of the fracture surface from LM-418 where multiple cracks have started as a result of multiple large pits formed during the anodising process. In general, both the pre-IVD etched coupons and the anodised coupons had many more initiation sites than the machined (N6) and the machined and polished (#400) coupons, most notably in the case of the low Kt coupons.

Figure 28: A pit formed from the dissolution of a particle inclusion on coupon LM-136

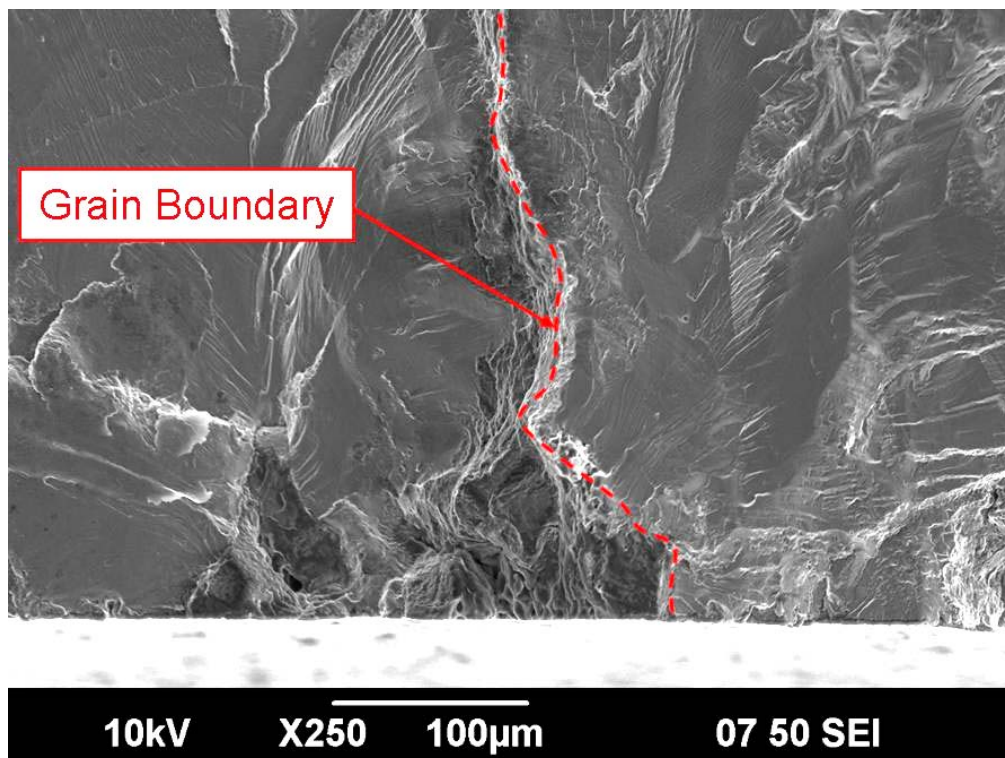
Figure 29: A pit formed by attacking a grain boundary on coupon LM-87

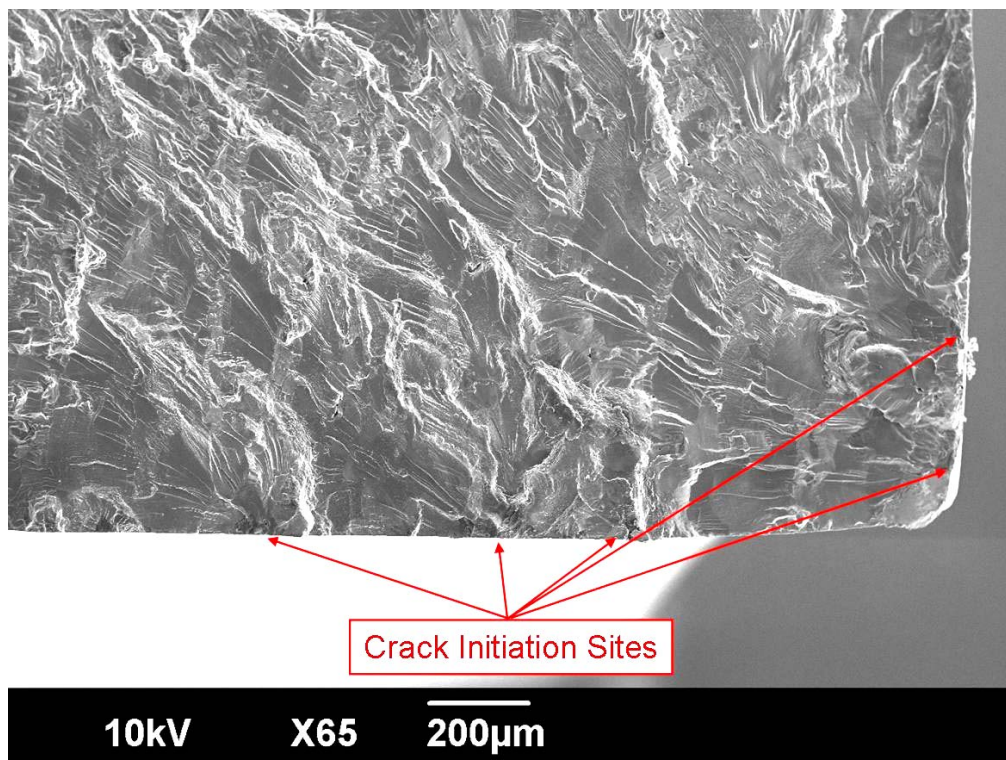
Figure 30: Multiple crack initiation sites on coupon LM-418

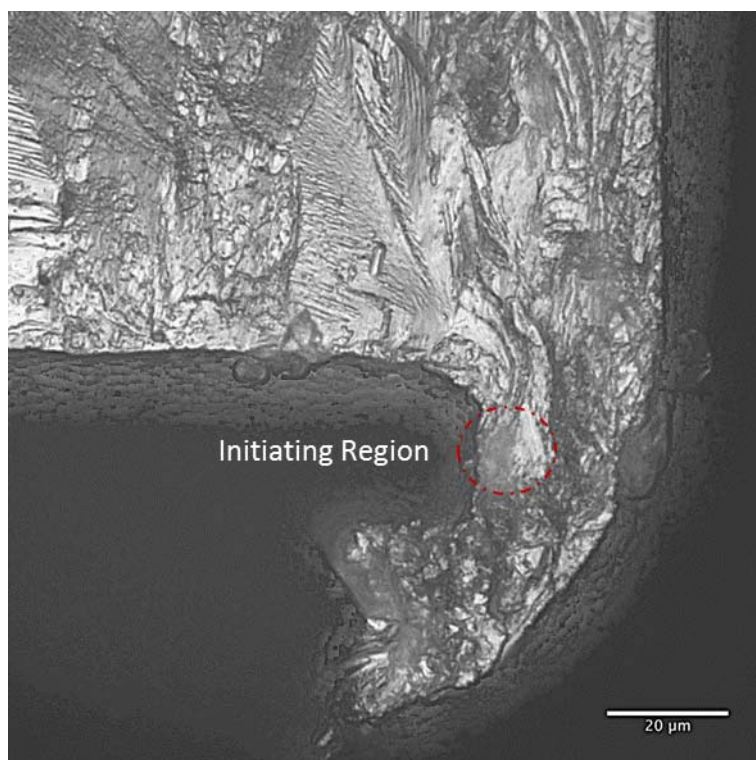
Figure C2: Initiating flaw of KK1H100 (the crack initiated from a machining burr and therefore the exact initiation point and features were difficult to determine)
